MINNESOTA HISTORIC PROPERTY RECORD

Bridge 9800, Lafayette Bridge

Bridge 9800 carries Minnesota Trunk Highway/United States Highway (TH/US) 52 over the Mississippi River in the city of St. Paul, Ramsey County, Minnesota.

The Lafayette Bridge (Bridge 9800) is a continuous steel deck girder span that carries Trunk Highway/United States Highway 52 (TH/US 52) over the Mississippi River in the city of St. Paul. It connects downtown St. Paul with West St. Paul and South St. Paul on the south, and links TH/US 52 with Interstate 94 (I-94) on the north. The Lafayette Bridge is situated east and downstream of the Robert Street Bridge (Bridge 9036, built in 1926) and the Wabasha Street Bridge (Bridge 62555A and 62555B, built in 2001). When completed in 1968, the Lafayette Bridge was the first new river crossing in St. Paul in nearly 80 years.

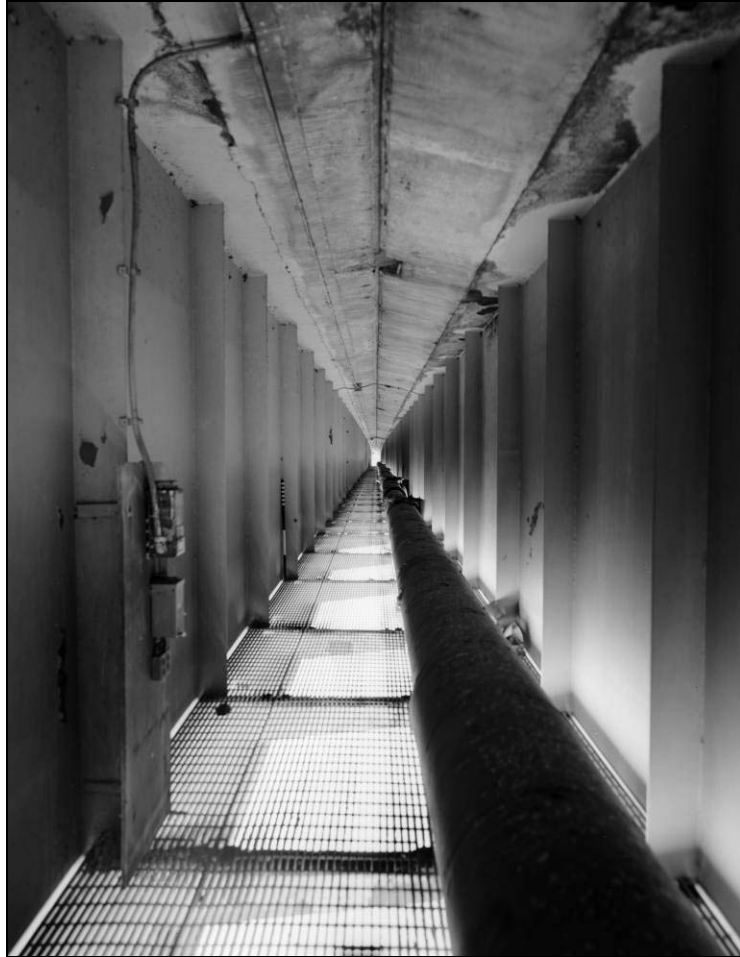
MHPR No. RA-SPC-7891-39

- RA-SPC-7891-39 VIEW OF SERVICE CATWALK BETWEEN NORTHBOUND AND
SOUTHBOUND SPAN 10, LOOKING SOUTH-SOUTHEAST. AREA OF
1975 GIRDER FRACTURE NEAR IMAGE MIDDLE-GROUND.

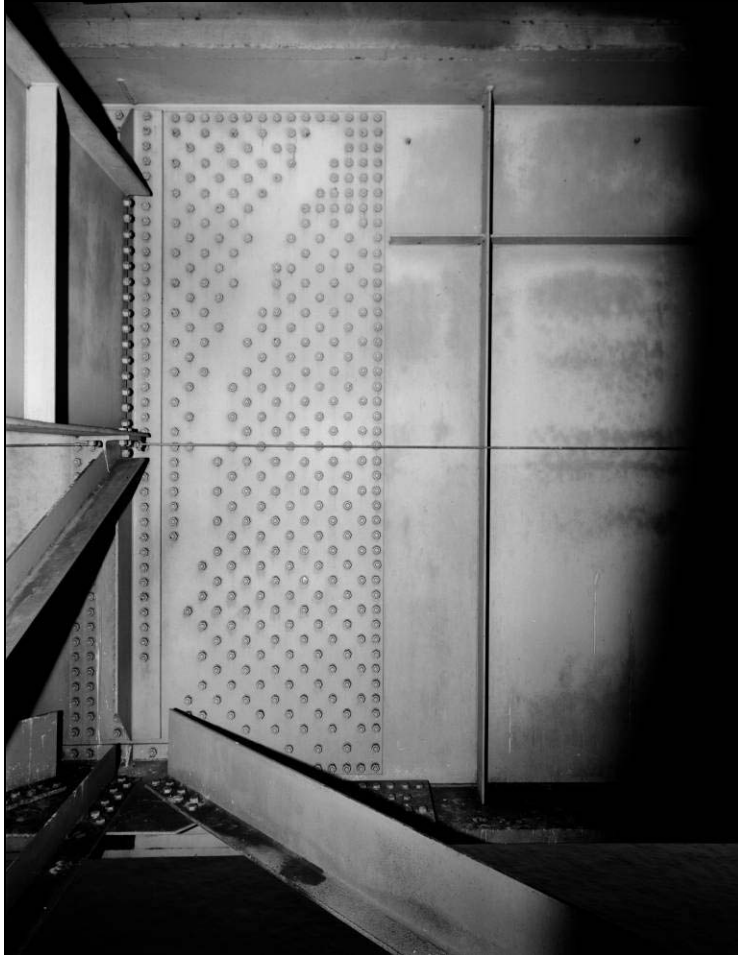
MHPR No. RA-SPC-7891-40

- RA-SPC-7891-40 VIEW OF WEST ELEVATION OF REPAIR PLATE AT 1975 GIRDER
FRACTURE SITE, LOOKING EAST-NORTHEAST.
- RA-SPC-7891-41 VIEW OF EAST ELEVATION OF UPPER PORTION OF REPAIR PLATE
AT 1975 GIRDER FRACTURE SITE, LOOKING WEST-SOUTHWEST.

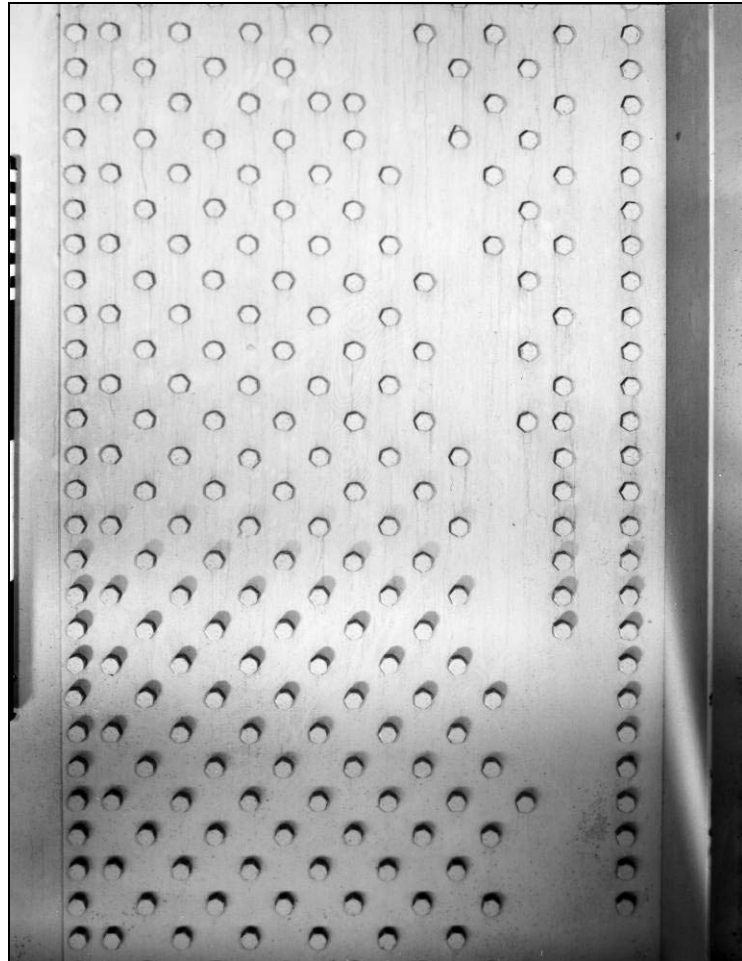
MHPR No. RA-SPC-7891-42

- RA-SPC-7891-42 VIEW OF EAST ELEVATION OF LOWER PORTION OF REPAIR
PLATE AT 1975 GIRDER FRACTURE SITE, LOOKING WEST-
SOUTHWEST. VIEW OF LOWEST PORTION OF REPAIR PLATE
BLOCKED BY STEAM UTILITY PIPE.

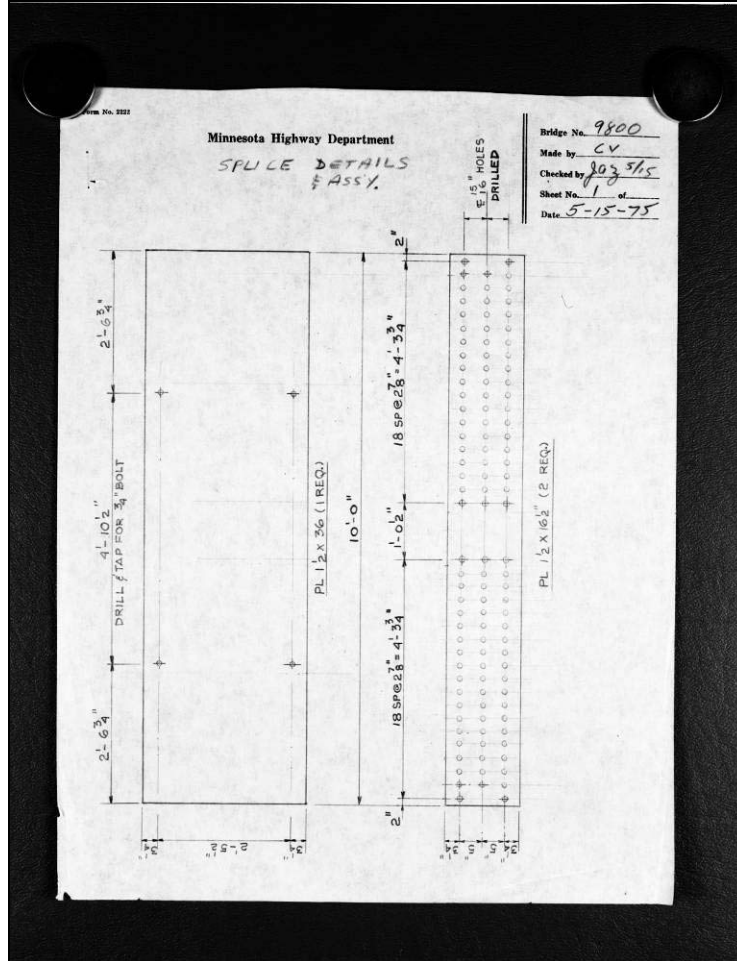
MHPR No. RA-SPC-7891-43

- RA-SPC-7891-43 FRACTURE REPAIR, HISTORICAL PLAN SHEET No. 1: SPLICE
DETAILS AND ASSEMBLY. DATED MAY 15, 1975. BRIDGE 9088
PROJECT RECORDS, MINNESOTA DEPARTMENT OF
TRANSPORTATION, SAINT PAUL, MINN.

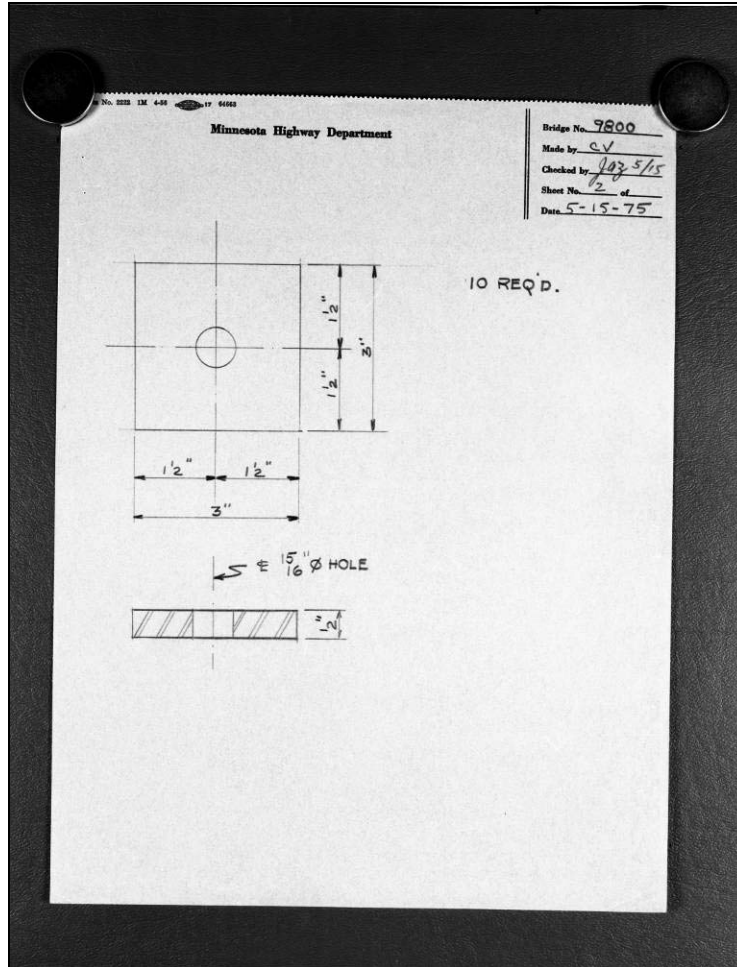
MHPR No. RA-SPC-7891-44

- RA-SPC-7891-44 FRACTURE REPAIR, HISTORICAL PLAN SHEET No. 2: UNTITLED
DETAILS. DATED MAY 15, 1975. BRIDGE 9088 PROJECT RECORDS,
MINNESOTA DEPARTMENT OF TRANSPORTATION, SAINT PAUL,
MINN.

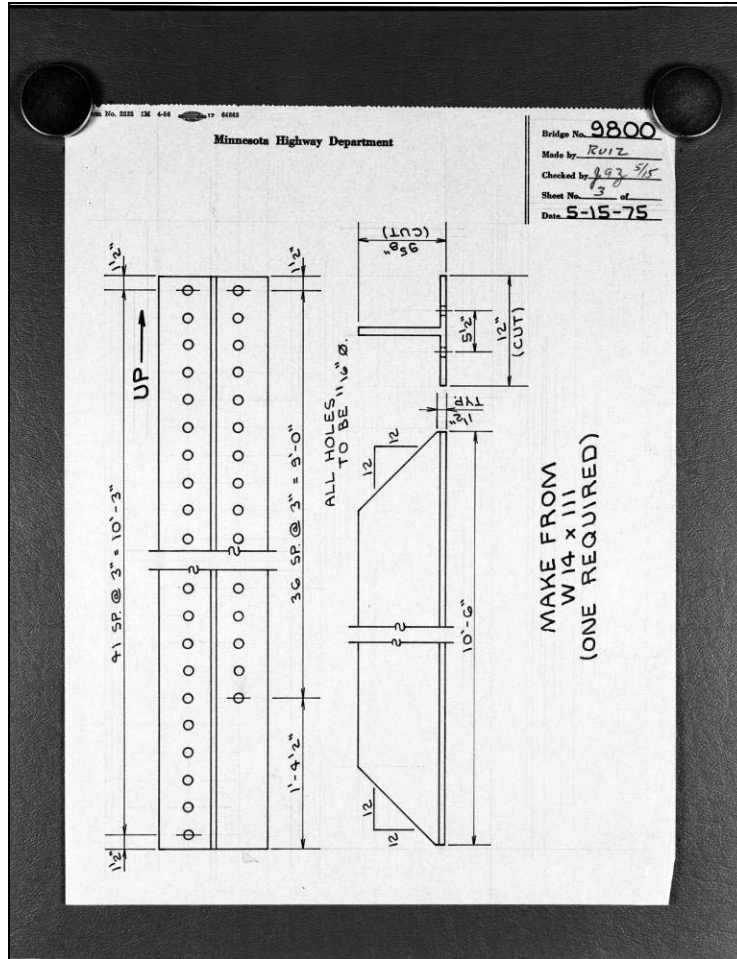
MHPR No. RA-SPC-7891-45

- RA-SPC-7891-45 FRACTURE REPAIR, HISTORICAL PLAN SHEET No. 3: UNTITLED
DETAILS. DATED MAY 15, 1975. BRIDGE 9088 PROJECT RECORDS,
MINNESOTA DEPARTMENT OF TRANSPORTATION, SAINT PAUL,
MINN.

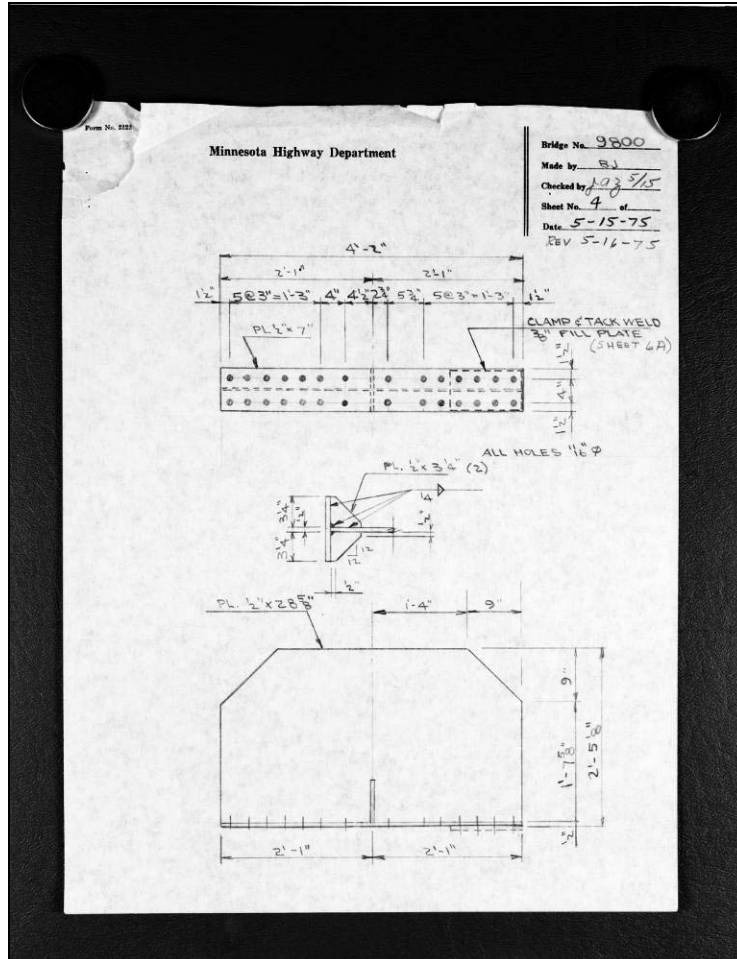
MHPR No. RA-SPC-7891-46

- RA-SPC-7891-46 FRACTURE REPAIR, HISTORICAL PLAN SHEET No. 4: UNTITLED
DETAILS. DATED MAY 15, 1975; REVISED MAY 16, 1975. BRIDGE
9088 PROJECT RECORDS, MINNESOTA DEPARTMENT OF
TRANSPORTATION, SAINT PAUL, MINN.

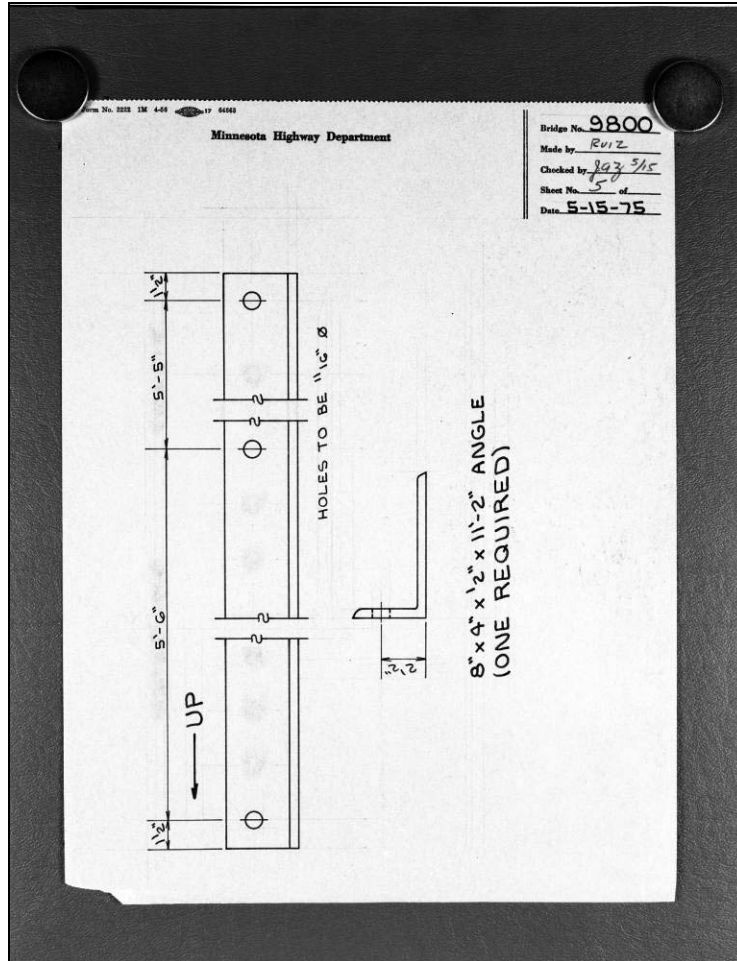
MHPR No. RA-SPC-7891-47

- RA-SPC-7891-47 FRACTURE REPAIR, HISTORICAL PLAN SHEET No. 5: 8" X 4" 1/2" X
11'-2" ANGLE. DATED MAY 15, 1975. BRIDGE 9088 PROJECT
RECORDS, MINNESOTA DEPARTMENT OF TRANSPORTATION,
SAINT PAUL, MINN.

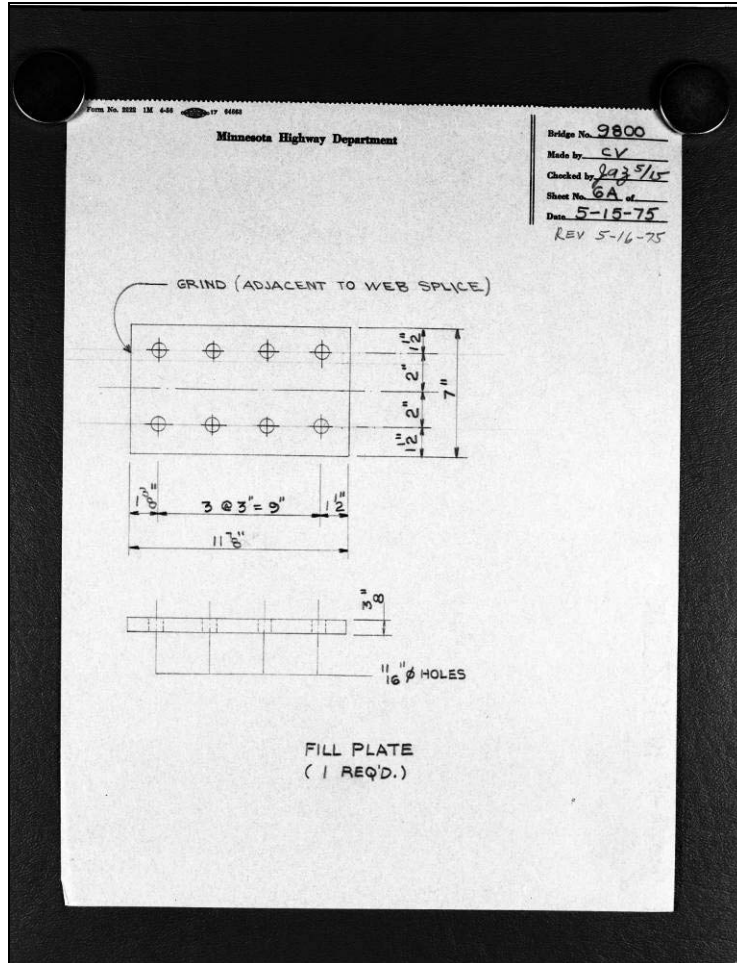
MHPR No. RA-SPC-7891-48

- RA-SPC-7891-48 FRACTURE REPAIR, HISTORICAL PLAN SHEET No. 6A: FILL PLATE.
DATED MAY 15, 1975. REVISED MAY 16, 1975. BRIDGE 9088

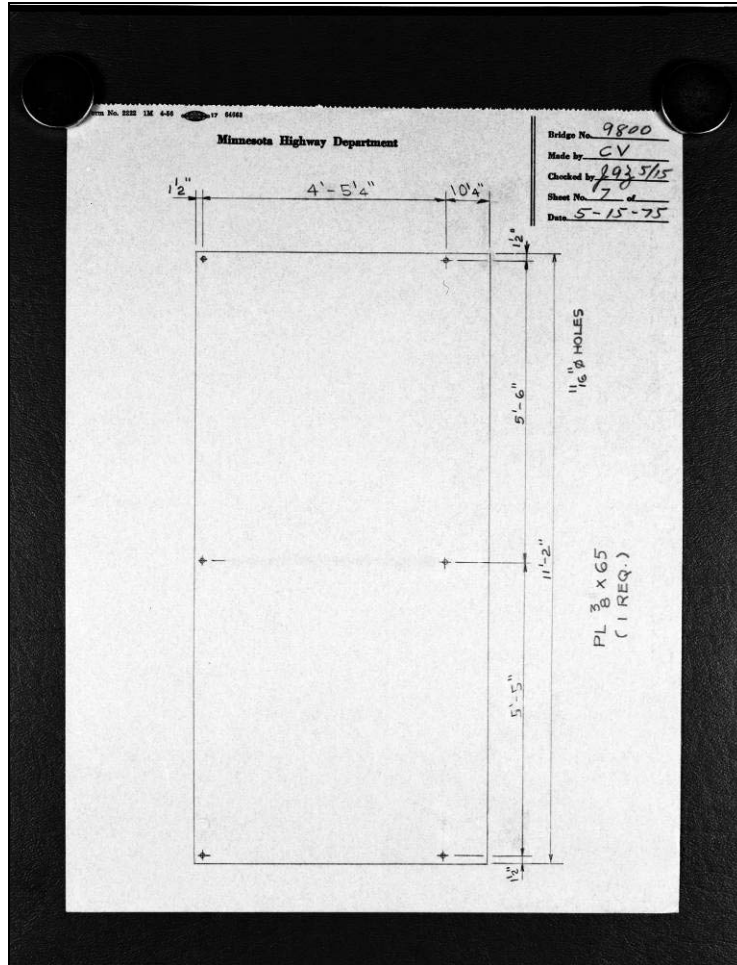
MHPR No. RA-SPC-7891-49

- RA-SPC-7891-49 FRACTURE REPAIR, HISTORICAL PLAN SHEET No. 7: PL 3/8 X 65. DATED MAY 15, 1975. BRIDGE 9088 PROJECT RECORDS, MINNESOTA DEPARTMENT OF TRANSPORTATION, SAINT PAUL, MINN.

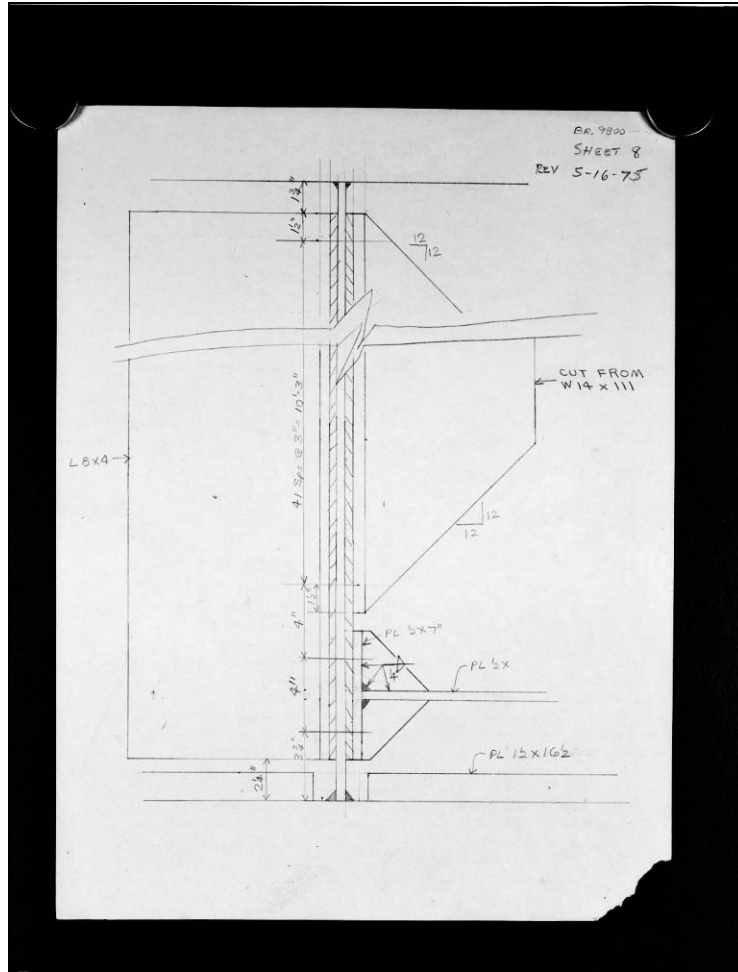
MHPR No. RA-SPC-7891-50

- RA-SPC-7891-50 FRACTURE REPAIR, HISTORICAL PLAN SHEET No. 8: UNTITLED DETAILS. REVISED MAY 16, 1975. BRIDGE 9088 PROJECT RECORDS, MINNESOTA DEPARTMENT OF TRANSPORTATION, SAINT PAUL, MINN.
